INVENTORY FORM FOR STATE HISTORIC SITES SURVEY

10 Linden Terrace

Towson

BA-2149

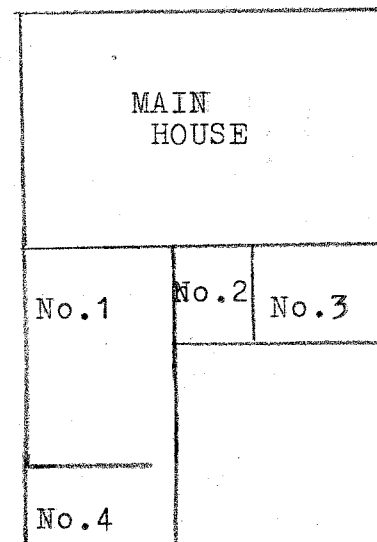
The south facade shows the changes brought about by several additions in the rear. The sketch below indicates the probable chronology of the various additions. It appears that the first addition (No.1) was added on the southwest corner of the house. This was approximately a 10 x 15 ft. addition. To the east side of this addition, a small addition (No.2) was made including a small porch (No.3), and stairs. Above this porch is a second-story porch exhibiting turned posts and and scroll brackets. To the rear of the first addition, an enclosed sun porch was added (No.4)

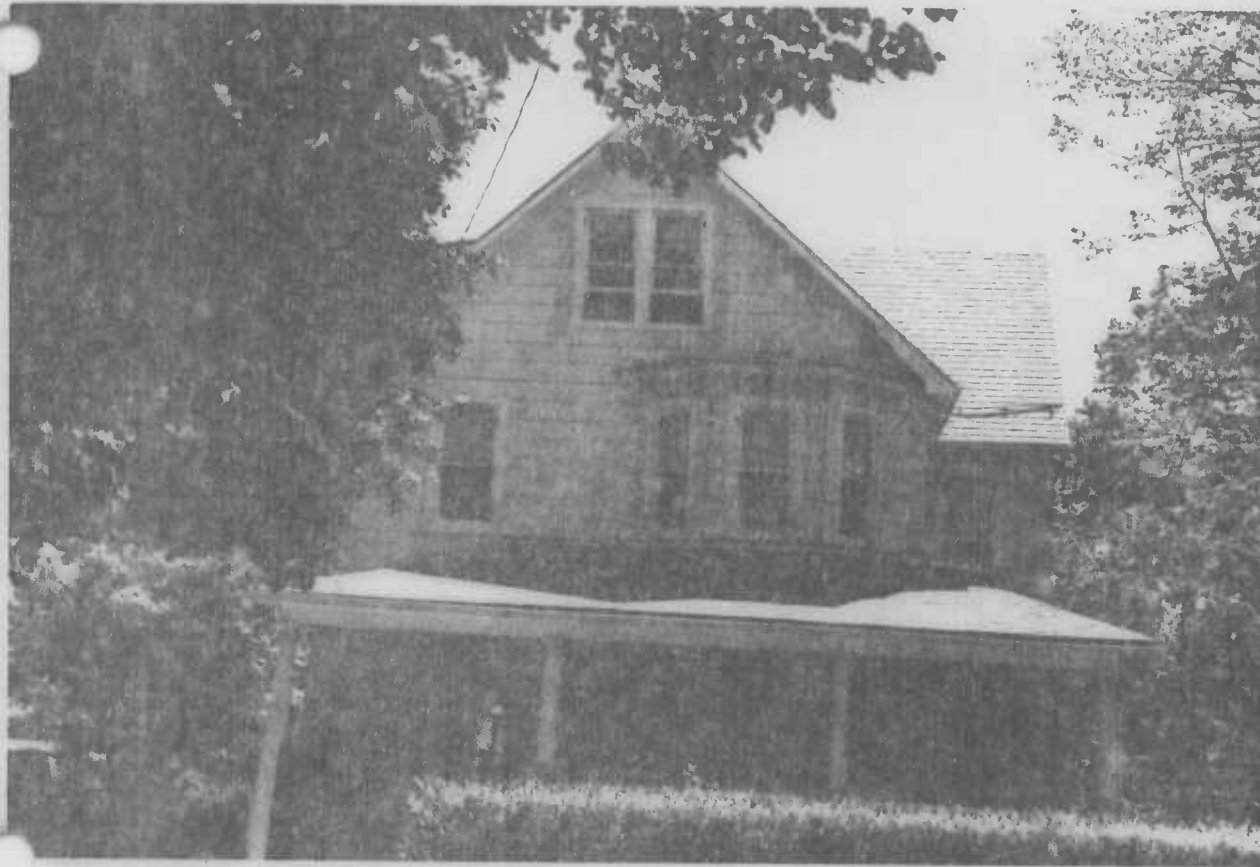
ABOVE: North (Main) Facade

The house faces north on Linden Terrace. Three wood steps lead to a large wrap-around porch with tongue and groove flooring. Five Doric wood columns resting on stone porch piers support the porch roof. The porch ceiling has been removed while work is being done on the porch rafters. A plain balustraded railing surrounds the porch.

The formal entrance is located on the east or left side of this north facade. It consists of a four paneled wood door with inset glass transom above. A plain cornice and architrave trim surround the door. Above the entrance on the second floor is a 1/1 double hung sash window. To the right of the door is a two-story bay window with plain cornice. It is comprised of six 1/1 sash windows. Walking around the porch from the bay window one finds a second entrance located on the north facade of the east-west wing. A wood screened door opens onto a six paneled wood interior door. A glass transom hangs above the entrance. On the second floor above this entrance is a 1/1 double hung sash window with plain white trim. A 1/1 double window is located in the attic. A deck area has been built on top of the porch roof in front of the second story bay window.
